THE STATE OF ONONDAGA LAKE

2001

ONONDAGA LAKE CLEANUP CORP.

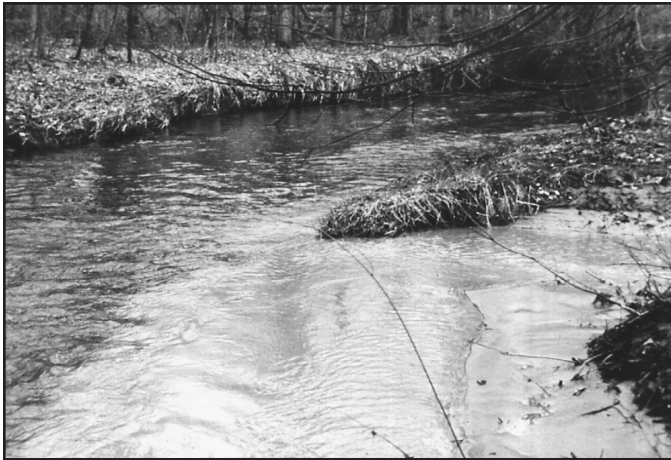
Mudboil discharges sediment to Upper Onondaga Creek

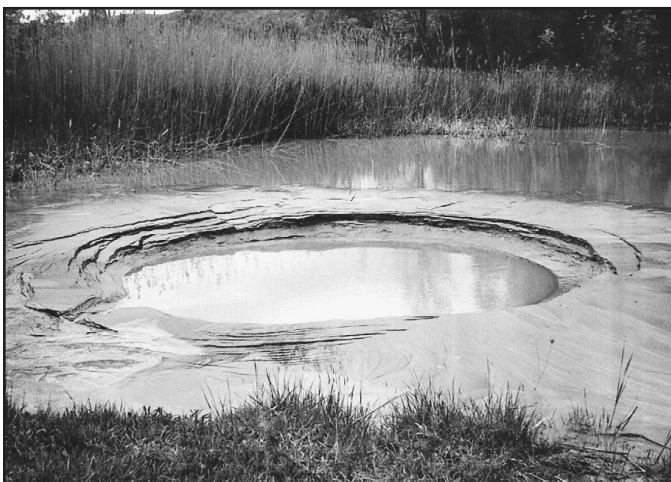
Tully Valley mudboil

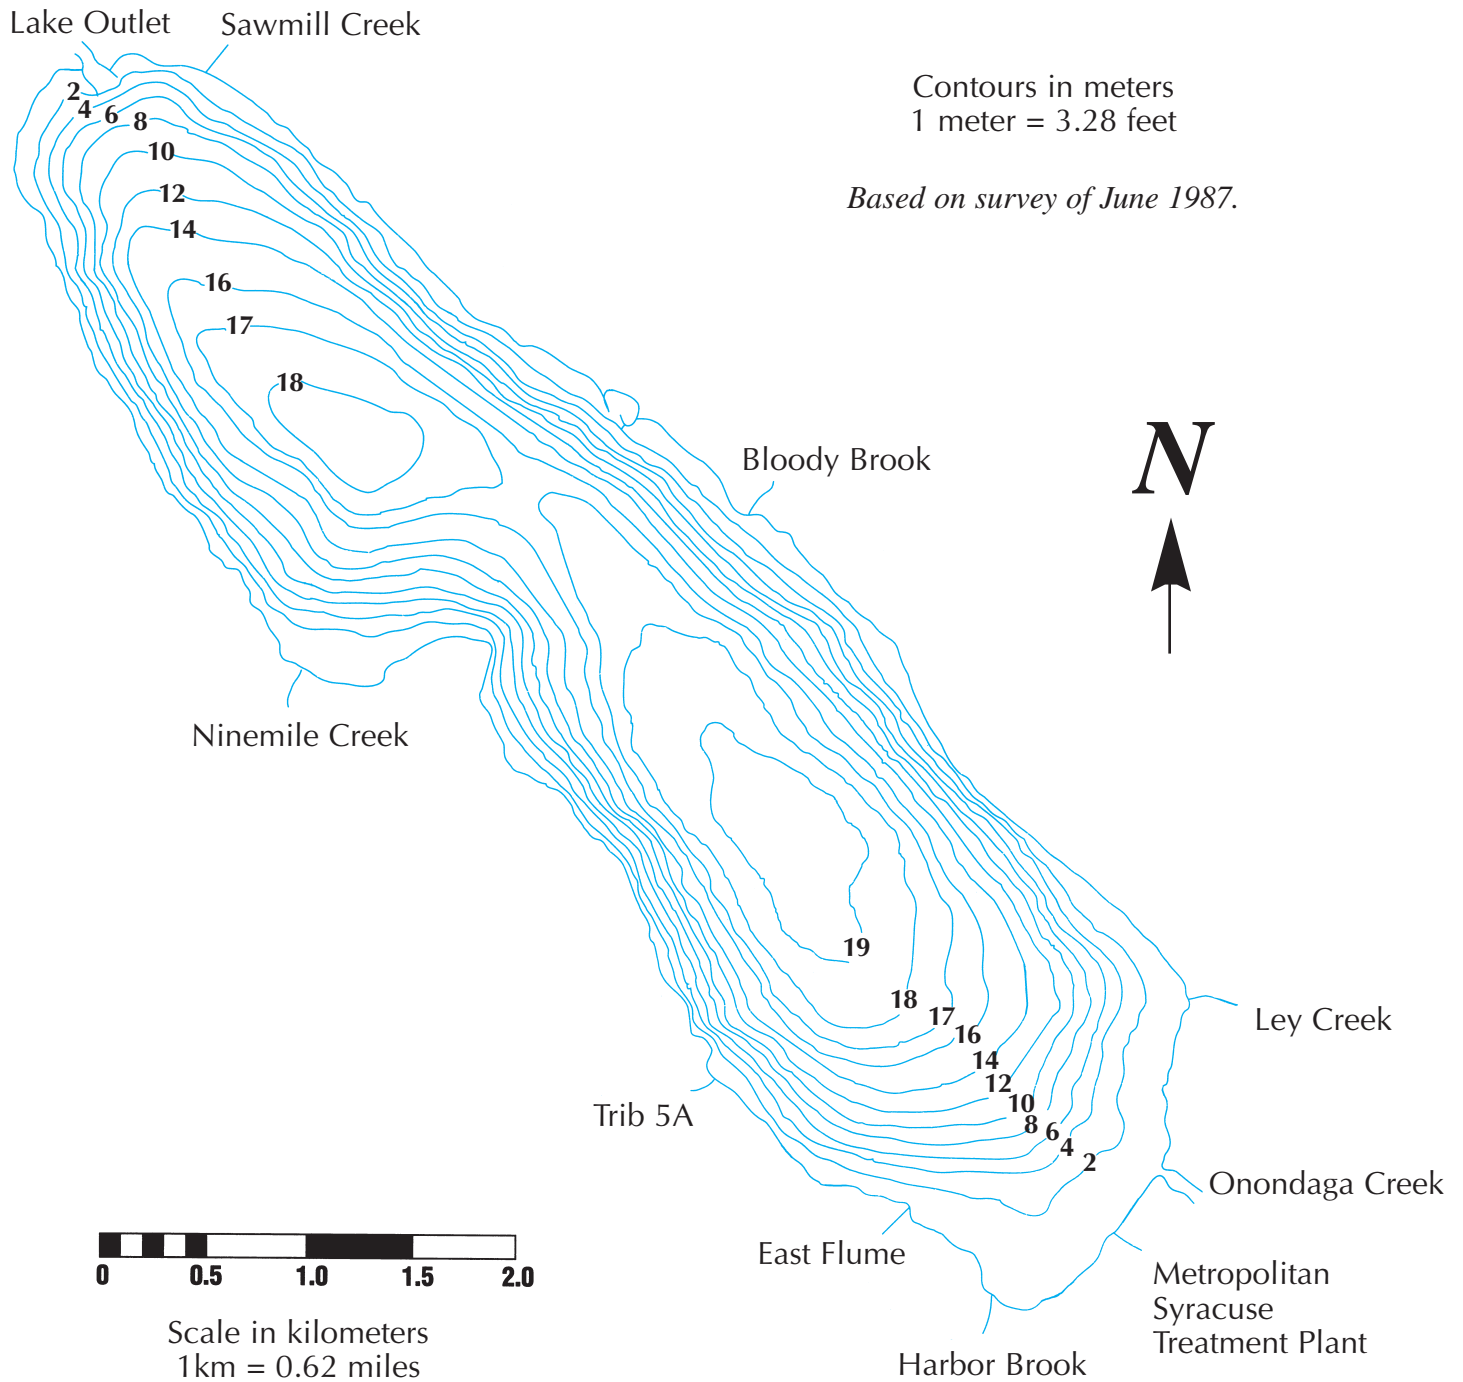
Bathymetric Map of Onondaga Lake

Onondaga County, New York
